Village of Mount Prospect, Illinois

# 2015 Combined Sewer Televising Condition Assessment

**BAXTER & WOODMAN**  
Consulting Engineers

Final Report  
August 2015

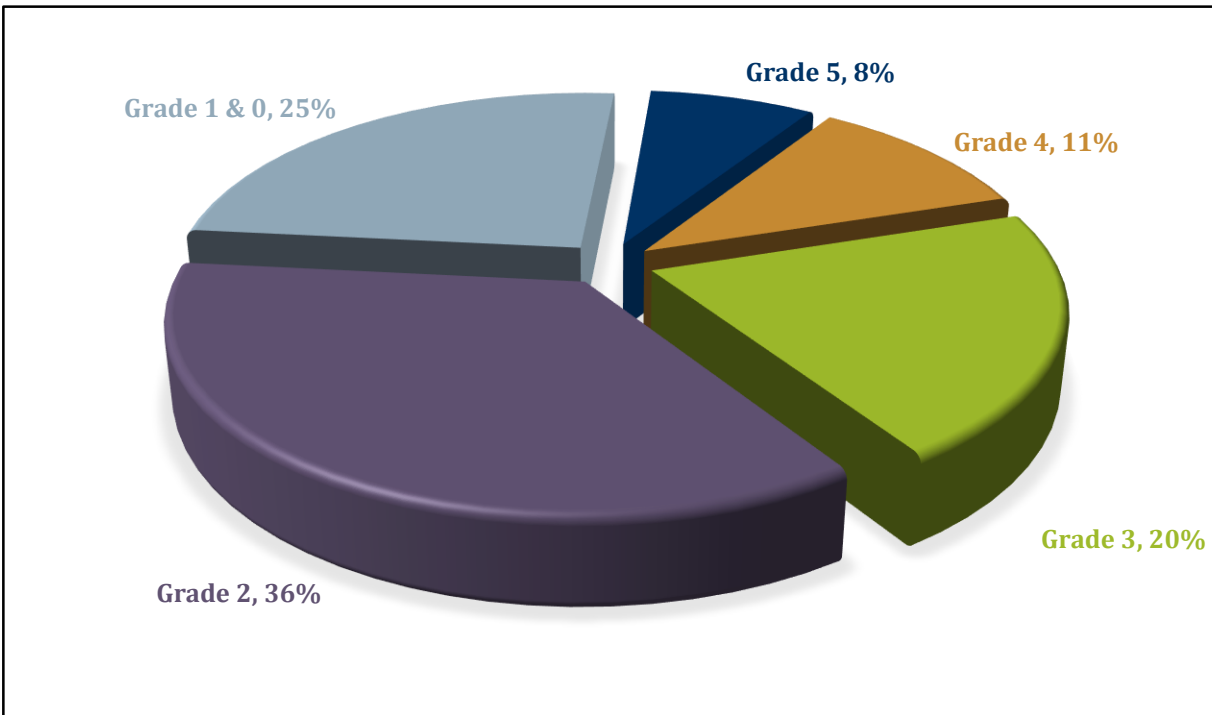
**FIGURE 1**

**Structural Pipe Grade Totals - 2002**

As the figure shows, approximately 40% of the sewers inspected fell into the Grades 3, 4 and 5 categories. These sewers ranged in age from approximately 50 to 80 years old. Recall that all of the Grade 4 and 5 repairs were completed as well as approximately 31% of the Grade 3 sewers.

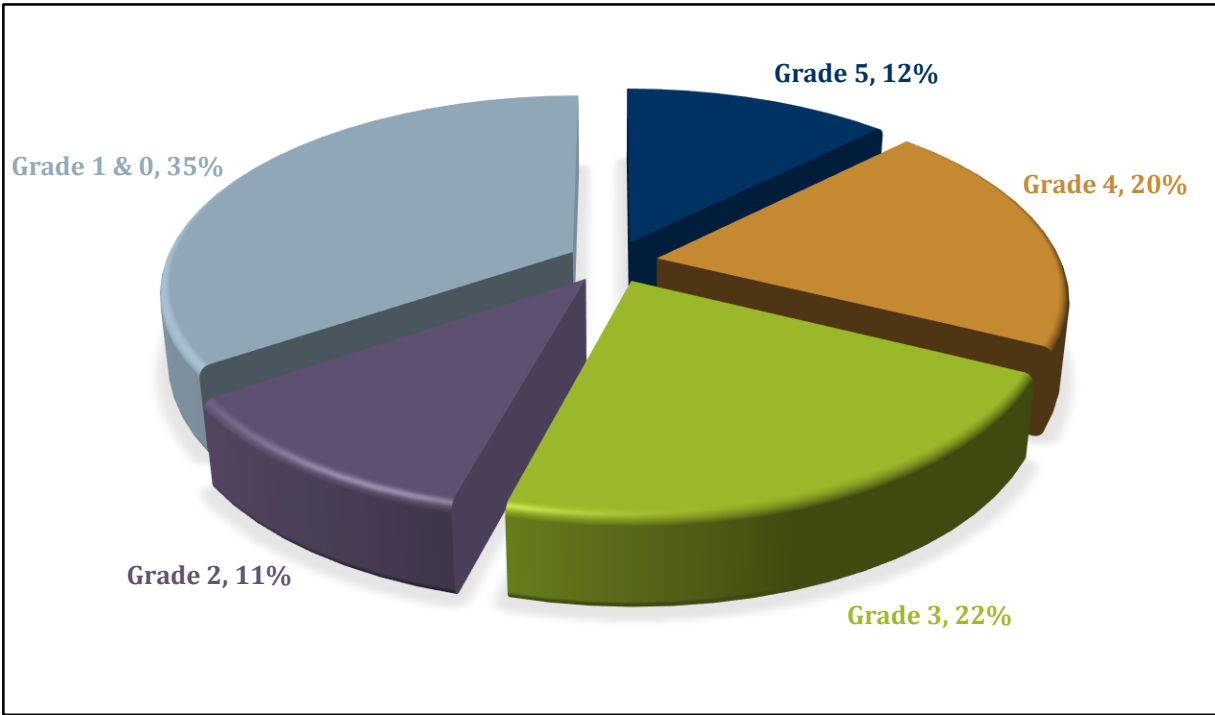
**FIGURE 2**  
**Structural Pipe Grade Totals - 2015**

As the figure shows, in the past 13 years, approximately 32% of the previous Grades 1, 2 and 3 defects are now Grades 4 and 5.

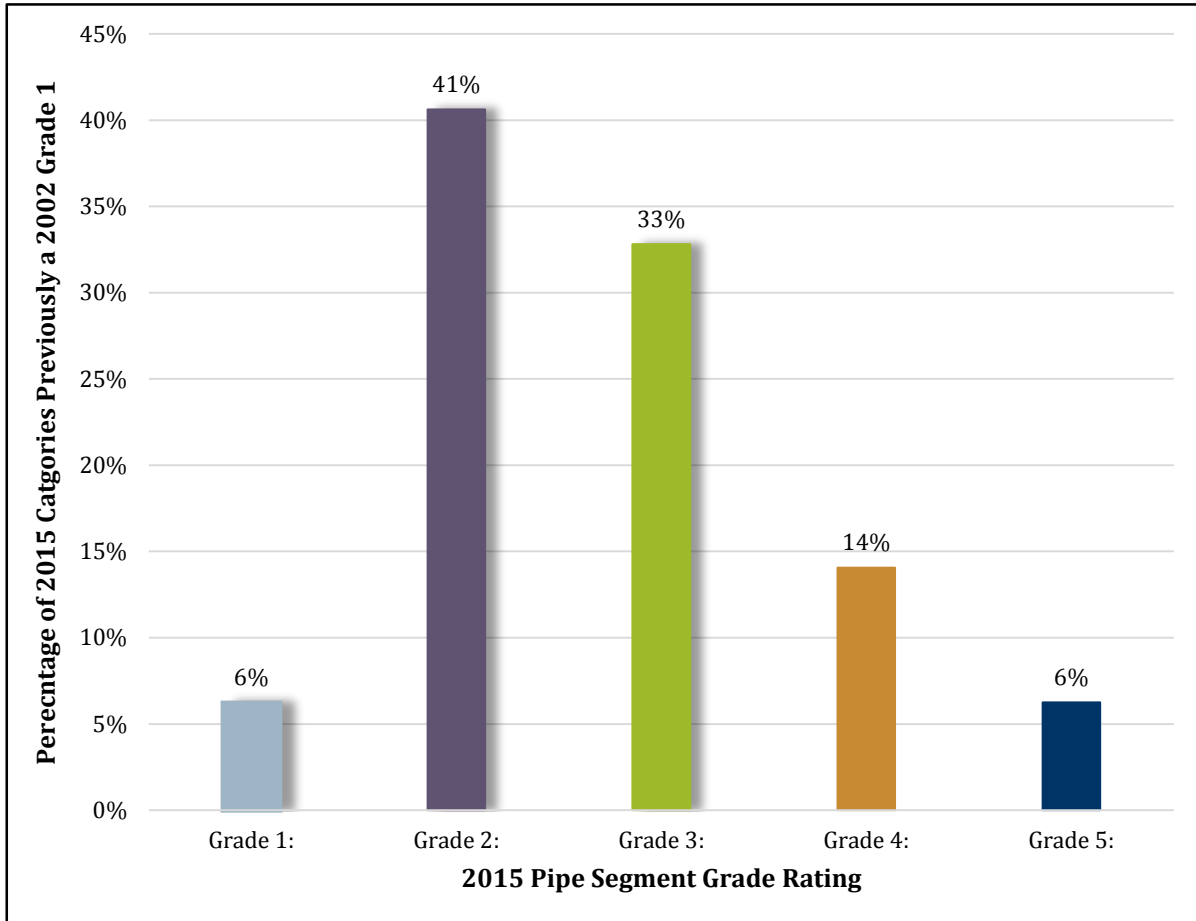
**FIGURE 3**  
**2002 Pipe Segment Grade 1**

Figure 3 shows the percentages of previous Grade 1 sewers that are now Grades 1, 2, 3, 4 or 5.

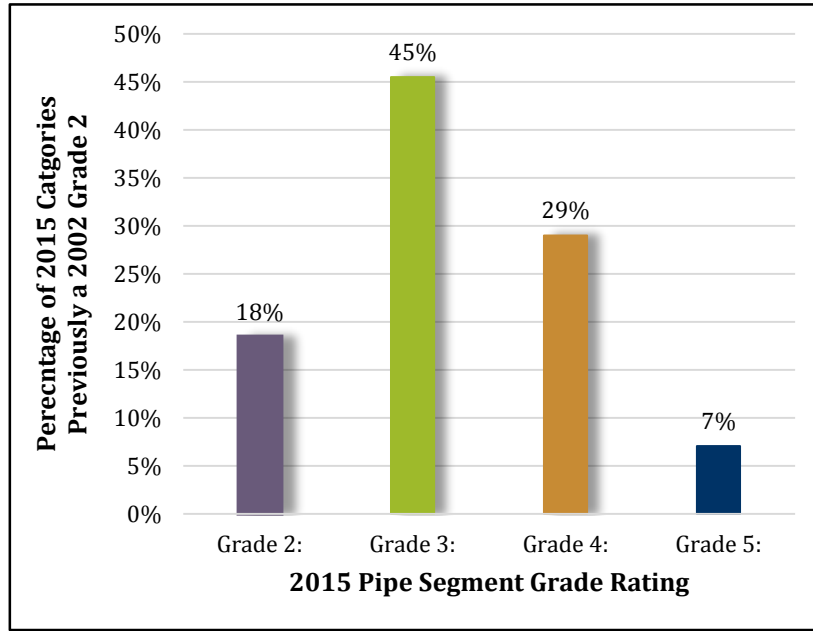
**FIGURE 4**  
**2002 Pipe Segment Grade 2**

Figure 4 shows the percentage of previous Grade 2 sewers that are now Grades 2, 3, 4 or 5.

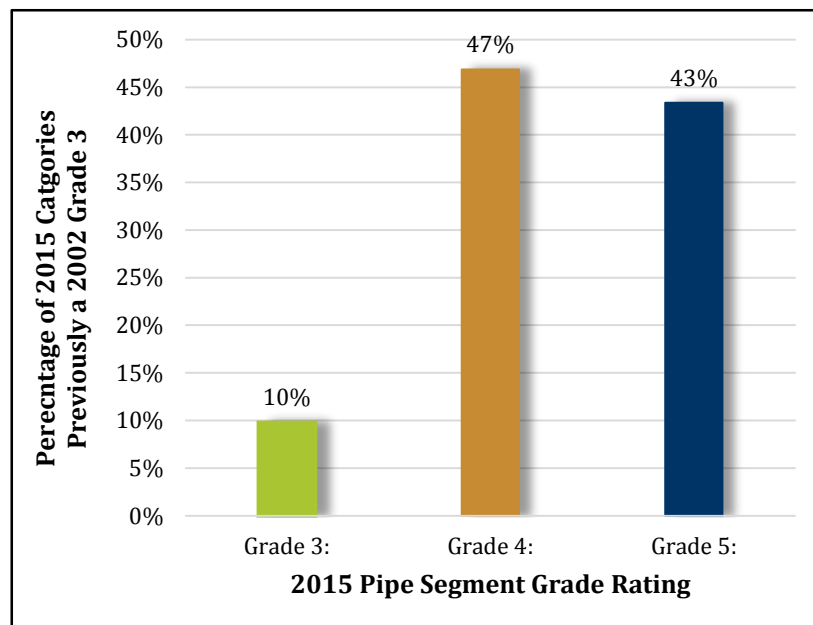
**FIGURE 5**  
**2002 Pipe Segment Grade 3**

Figure 5 shows the percentage of previous Grade 3 sewers that now Grades 3, 4 or 5.
